INVESTIGATION OF SITE COVERAGE AND ASSOCIATED PROBLEMS AT THE O'HARE AIRPORT, CHICAGO, ILLINOIS, ENROUTE RADAR BEACON TEST SITE

INTERIM REPORT

1. Report No. FAA-RD-73-49		2. Government Accession No.		3. Re	
4. Title and Subtitle (INVESTIGATION OF SITE COVERAGE AND ASSOCIATED PROBLEMS AT THE O'HARE AIRPORT, CHICAGO, ILLINOIS, ENROUTE RADAR BEACON TEST SITE)				5. Report Date April 1973

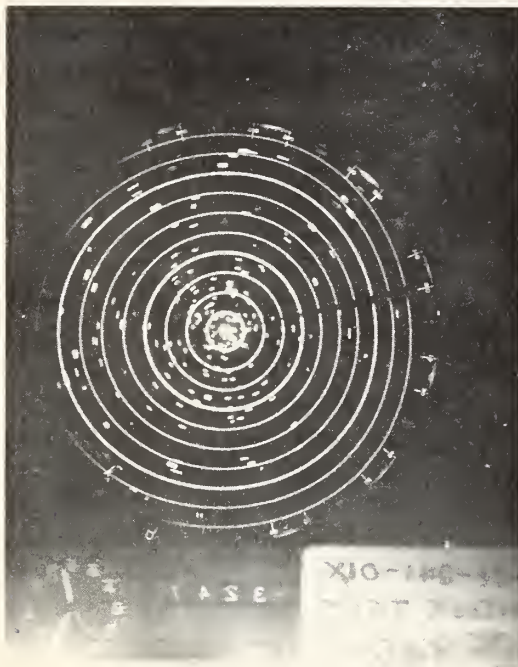
FIGURE 12. LOSS OF BEACON REPLIES DUE TO VERTICAL LOBING ON THE 13° RADIAL OF THE BEACON TEST SITE

During the analysis of the targets-of-opportunity data at NAFEC, it was noted that aircraft replies were lost north of the beacon test site as aircraft flew along Jet Airway 38-106. The loss of replies occurred at 10° , 13° and 20° to a large number of aircraft that flew through the area. The range where the beacon replies were lost on Jet Airway 38-106 was approximately 145 nmi from the beacon test site. Figure 12 shows an example of the vertical lobing that occurred in this area. A series of photographs are shown so that the loss of the beacon reply could be associated with the position of the aircraft prior to and after the time the beacon reply was lost. The aircraft reply that exhibited vertical lobing was circled on the figure for easier identification.

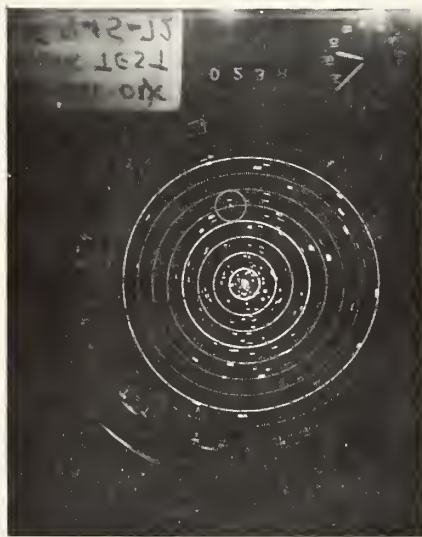
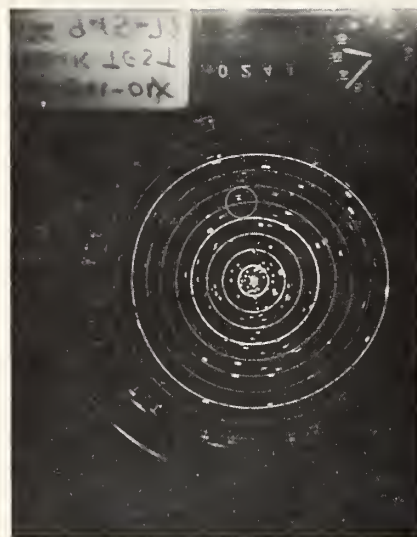
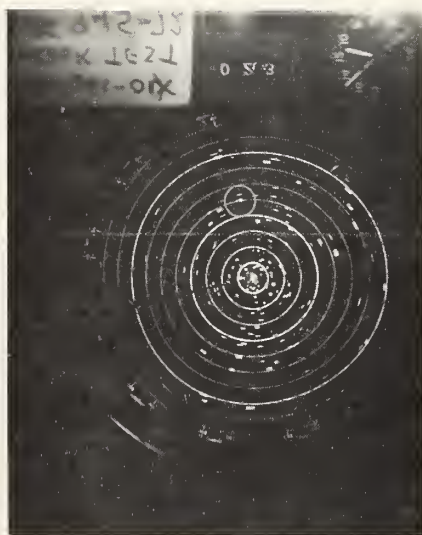
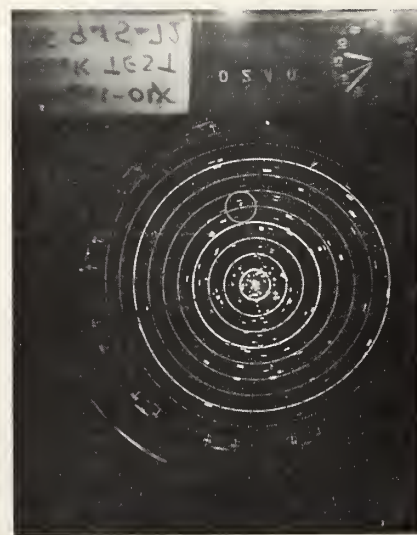
FIGURE 13. LOSS OF BEACON REPLIES DUE TO VERTICAL LOBING
ON THE 84° RADIAL OF THE BEACON TEST SITE

During the analysis of the targets-of-opportunity data, vertical lobing was also noted in the vicinity of the 71° to 89° radial, at ranges approximating 100 to 138 nmi. Aircraft flying on Jet Airways 94-547 and 584 covered these radials during their outbound and inbound flights. The three azimuths where the vertical lobing was most intense were 71°, 84°, and 89°. Vertical lobing was noted at two ranges on the 84° and 89° radials. Only one area of vertical lobing was noted on the 71° radial, this occurred at 130 nmi. Figure 13 shows an example of vertical lobing that took place on the 84° radial at 100 nmi.

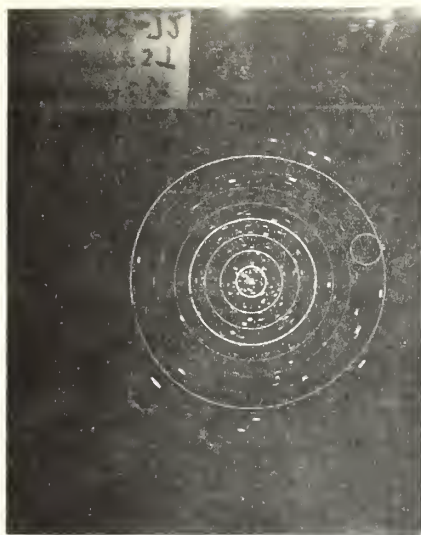
FIGURE 14. LOSS OF BEACON REPLIES DUE TO VERTICAL LOBING
ON THE 172° RADIAL OF THE BEACON TEST SITE

Some loss of radar beacon replies was observed on the targets-of-opportunity data when aircraft flew in the vicinity of the 164° radial at ranges between 140 to 157 nmi. and on the 172° radial at ranges approximating 142 nmi. The loss of beacon replies did not occur too often in this area and it was questionable whether the loss of replies in this area was really very serious. Figure 14 shows an example of the loss of beacon replies that occurred in the vicinity of the 172° radial at a range of 142 nmi.

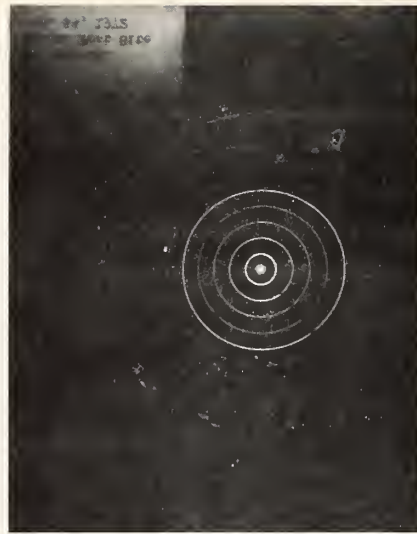
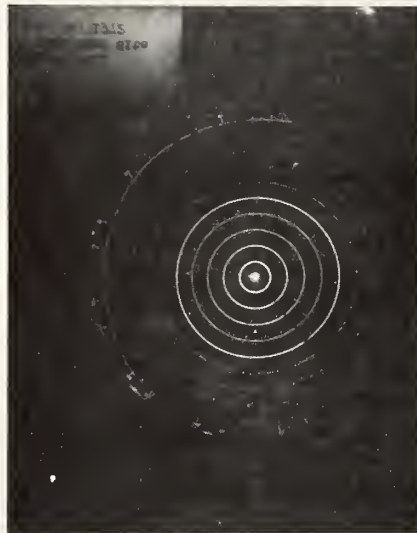
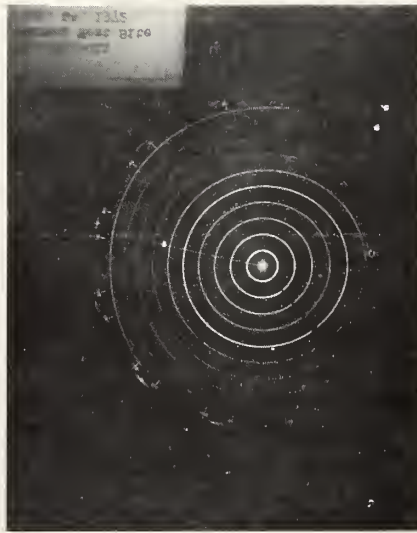
FIGURE 21. LOSS OF BEACON REPLIES DUE TO VERTICAL LOBING
ON 13° RADIAL OF THE BEACON TEST SITE DURING
NAFEC AIRCRAFT FLIGHT TESTS

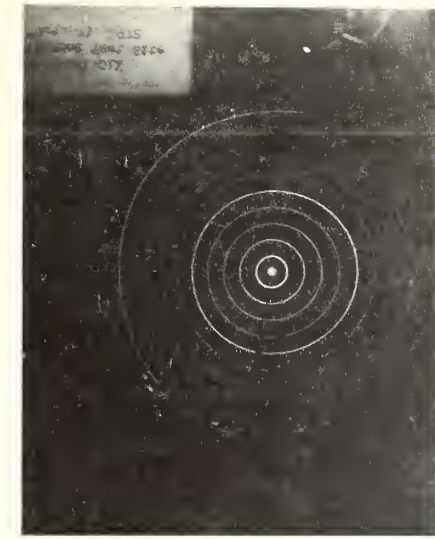
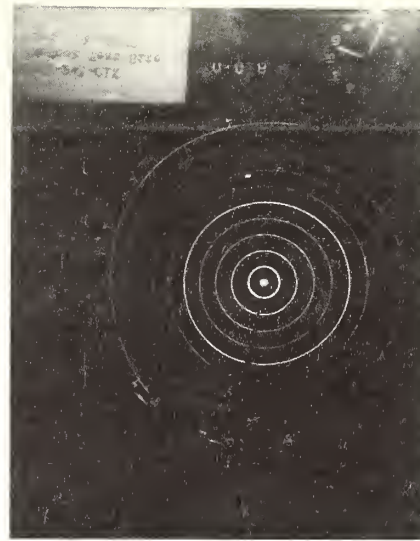
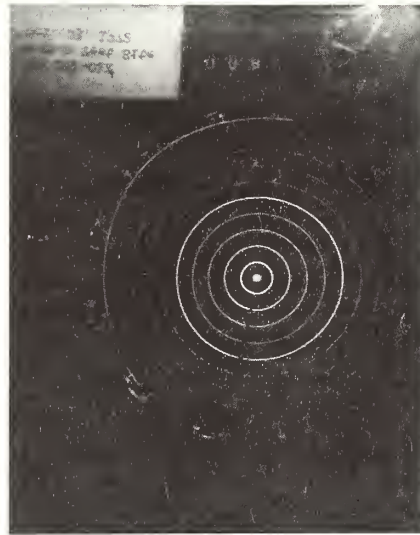
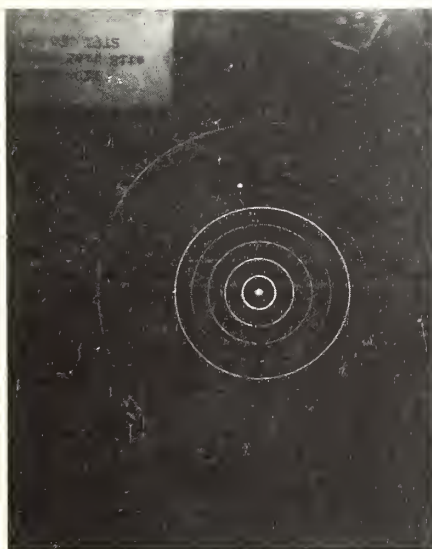
FIGURE 22. LOSS OF BEACON REPLIES DUE TO VERTICAL LOBING
ON 84° RADIAL OF THE BEACON TEST SITE DURING
NAFEC AIRCRAFT FLIGHT TESTS

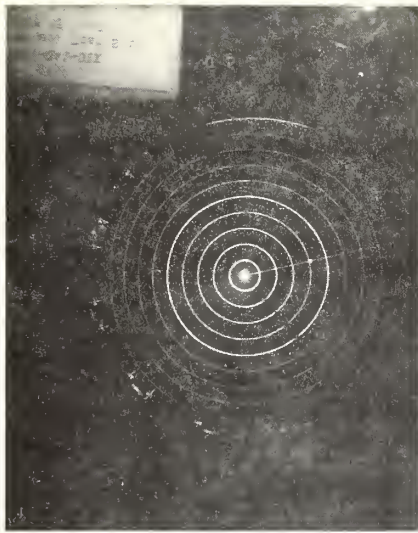
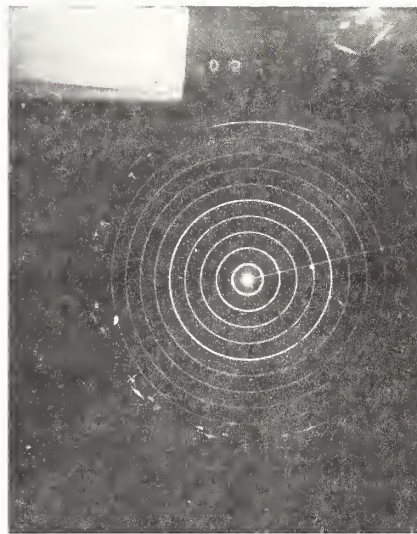
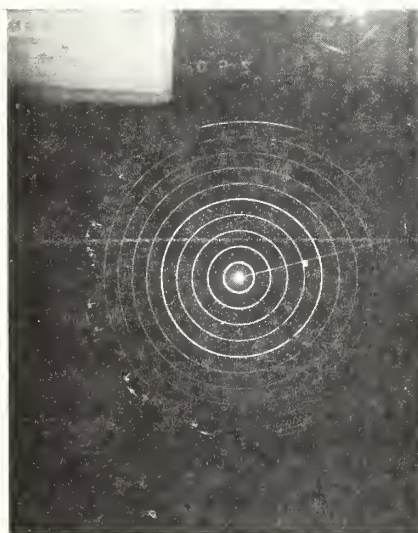
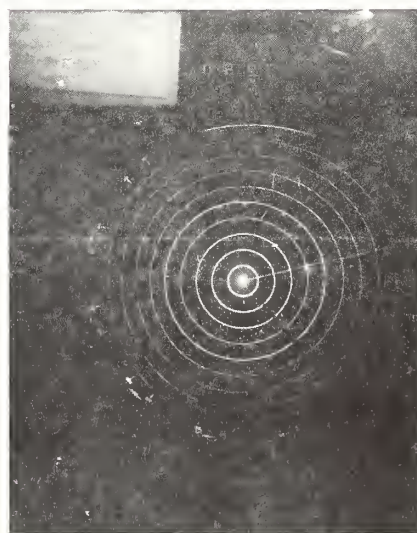
FIGURE 23. REDUCTION OF BEACON REPLIES DUE TO VERTICAL LOBING ON 170° RADIAL OF THE BEACON TEST SITE DURING NAFEC AIRCRAFT FLIGHT TESTS

The flight testing that was conducted on 5 October, using the NAFEC aircraft, commenced by investigating the 165° to 175° beacon test site radials at 27,000 to 29,000 feet. The flight tests were made in an attempt to produce losses of beacon replies in this area, but no complete loss of beacon replies was noted except during turn maneuvers. Some narrowing of the beacon reply was recorded on the 162° radial at 72 nmi and on the 170° radial at 79 nmi. Figure 23 shows the narrowing of the beacon reply that occurred on the 170° radial at 79 nmi.

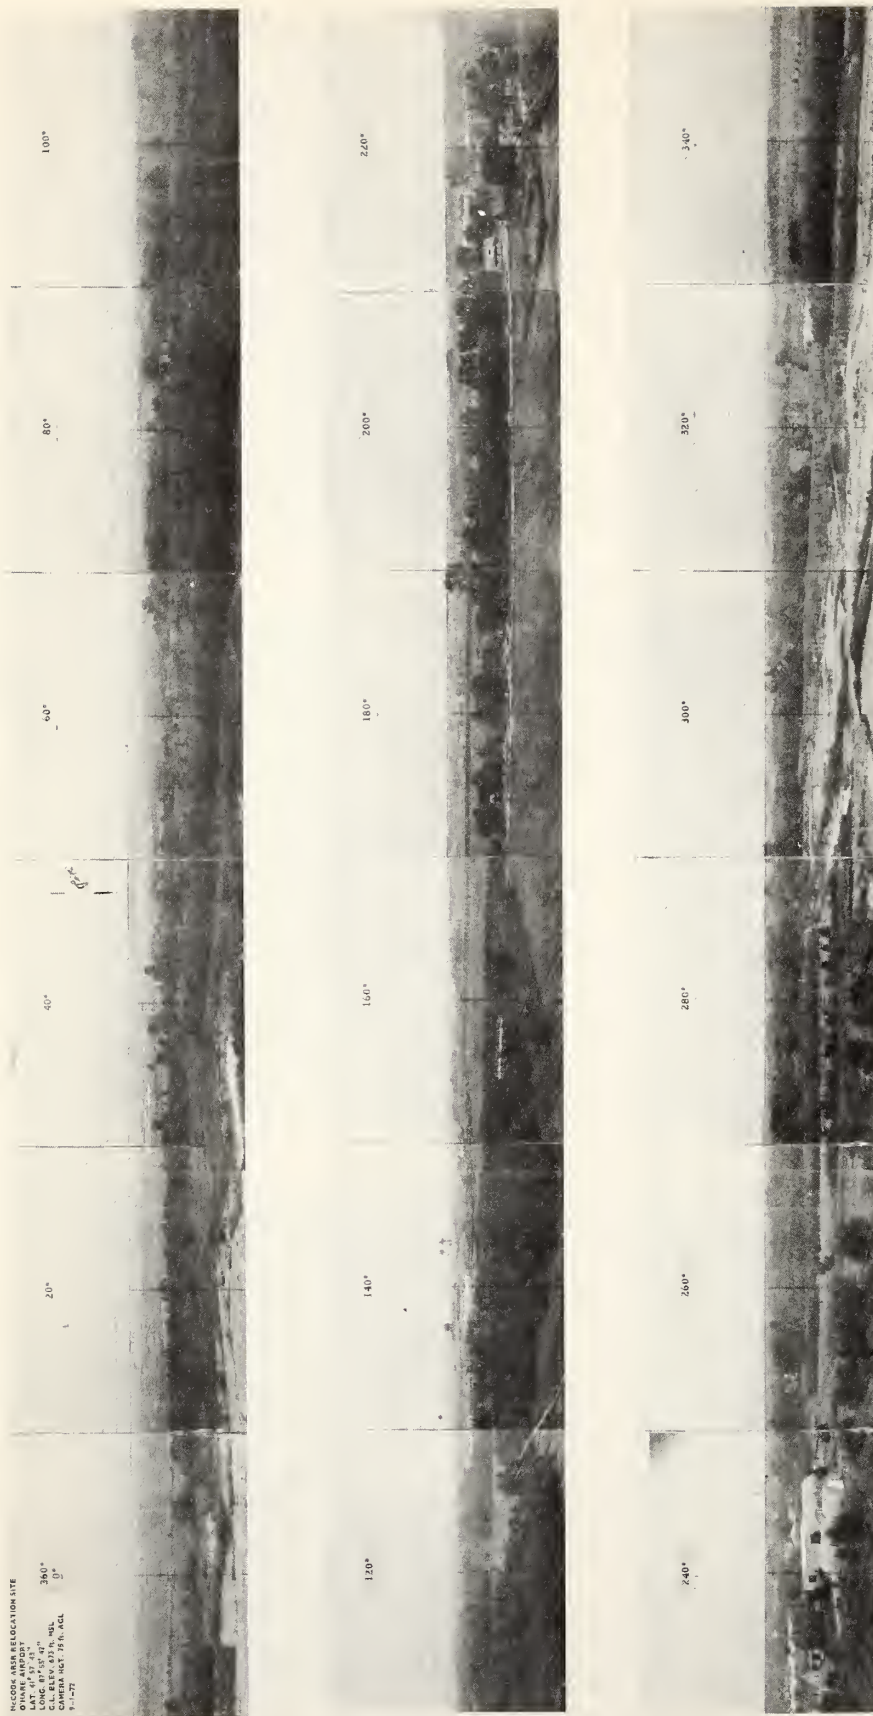
FIGURE 24. PANORAMIC VIEW OF TERRAIN SURROUNDING THE
 BEACON TEST SITE FROM A HEIGHT OF 75 FEET
